## 1995 Aerial Photomosaic - North Cove, WA

### Other Issues for Willapa and Grays Harbor Bays:

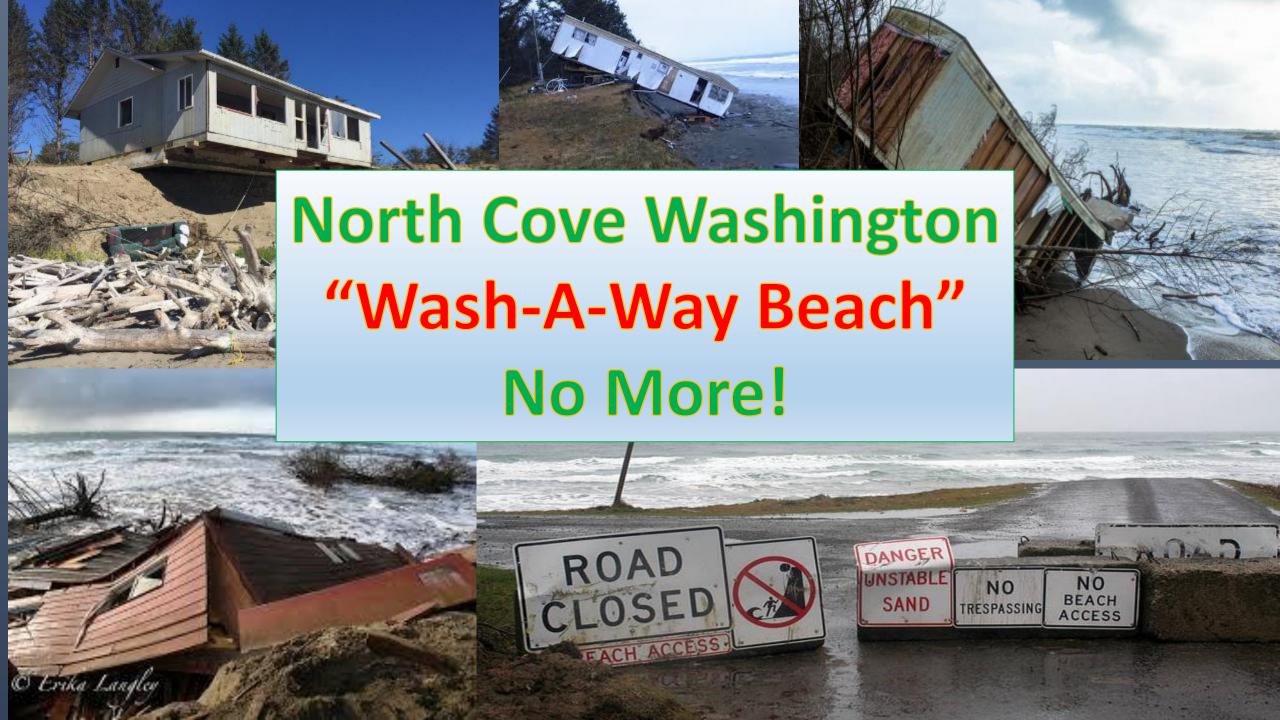
/ 1870s shoreline

1920s shoreline

1950s shoreline

1995 shoreline

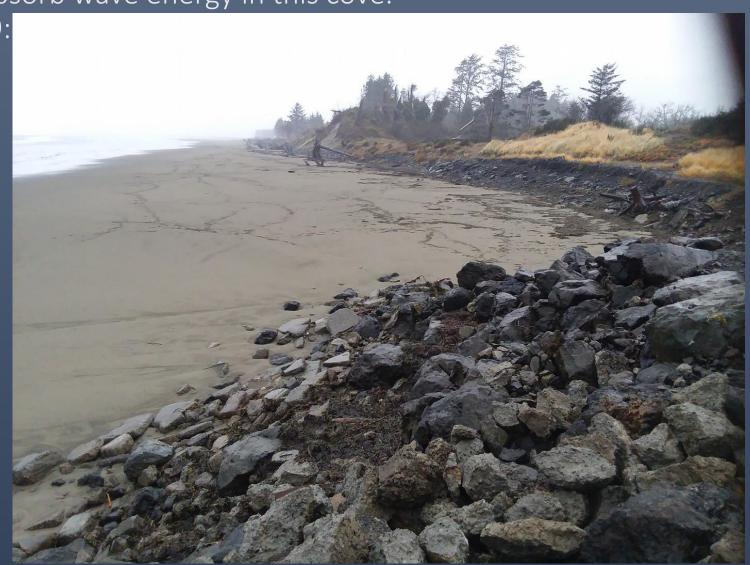
13 December 2019:

This is the view northwest from the end of Seamobile Drive. We extended our "speedbump" to absorb wave energy in this cove.

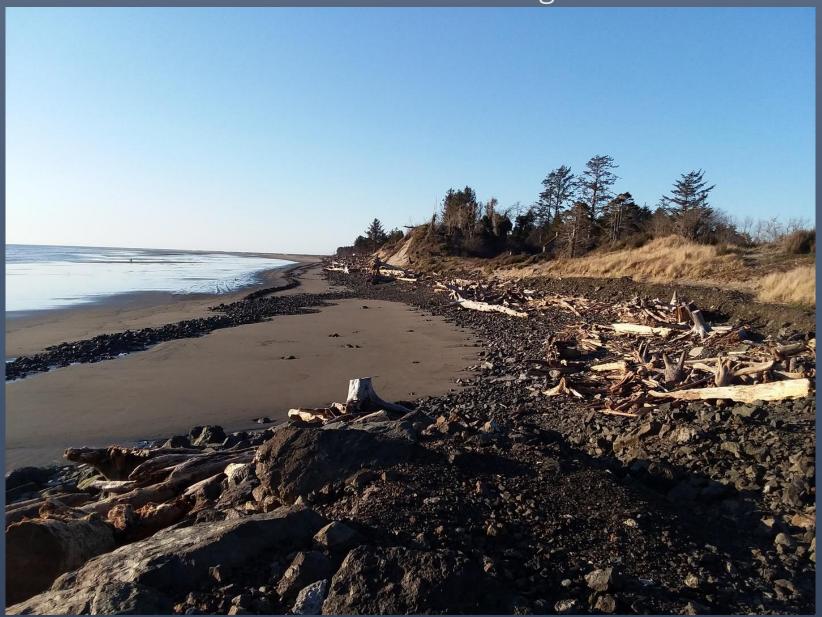
wood too. 8 February 2020:

Prior speedbumps, constructed during this project, have spread rock to optimum the slope of the revetment. And waves brought us lots of

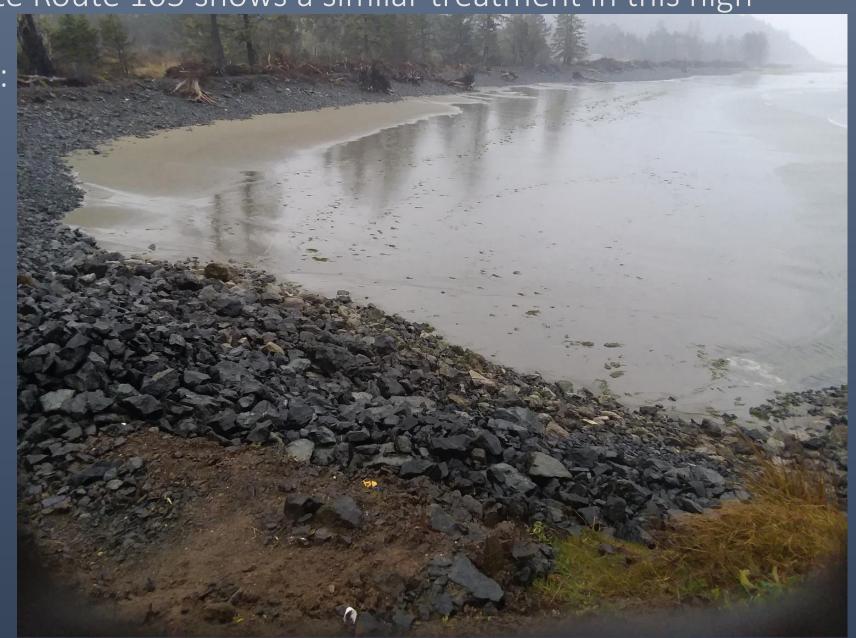
11 December 2019:

Looking off Old State Route 105 shows a similar treatment in this high

energy area.
